"Spaghetti Solar"
A photographic survey of African off grid PV systems
Eric Youngren
Solar Nexus International
March 2009

One of the goals of my recent trip to Africa was to assess the current state of off-grid electric technology use in Africa, with an eye towards developing new markets for Solar Nexus International. During my travels through Guinea Bissau, Tanzania and Uganda I tried to seek out and document as many existing PV systems as possible. I was hoping to make it an informal 'survey' of the currently operating systems. Whenever I saw PV panels on a roof or a rack I'd ask to see the batteries and the rest of the system. It was by no means comprehensive nor scientific (rating #'s are approximate) , but I did get to see a bunch of systems and developed a general impression on the state of the residential PV industry in Africa. I took some pictures and tried to document what I saw in terms of the quality of systems that are currently being installed and utilized in the countries I visited.

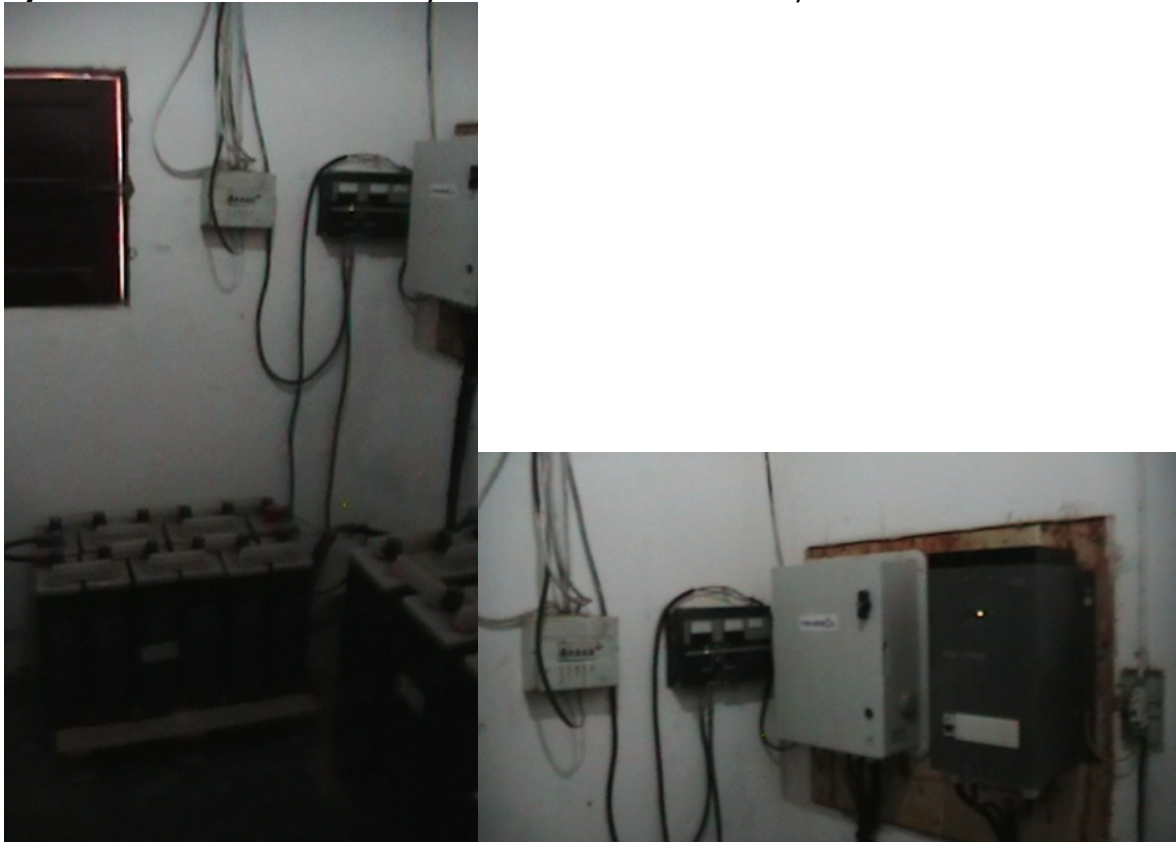
System #2 – ~1200 Watts PV, ~800 AH flooded battery @ 24 Volts

24V systems at a national park office in Guinea Bissau

This system is an a national park office in Guinea Bissau. Actually there are two systems operating in parallel. Together they run lighting, a computer, cellphone charging and substantial water pumping. It was 'professionally installed' and one of only two 24 Volt systems that I saw in Africa. The park rangers had a basic understanding of the system and had established a good procedure for re-filling the flooded batteries with distilled water (though it was not clear if was really distilled water, or just the same bottle reused and refilled with well water). It did have a main battery fuse and the array wire looked adequately sized, but as you can see the wiring is still a mess.

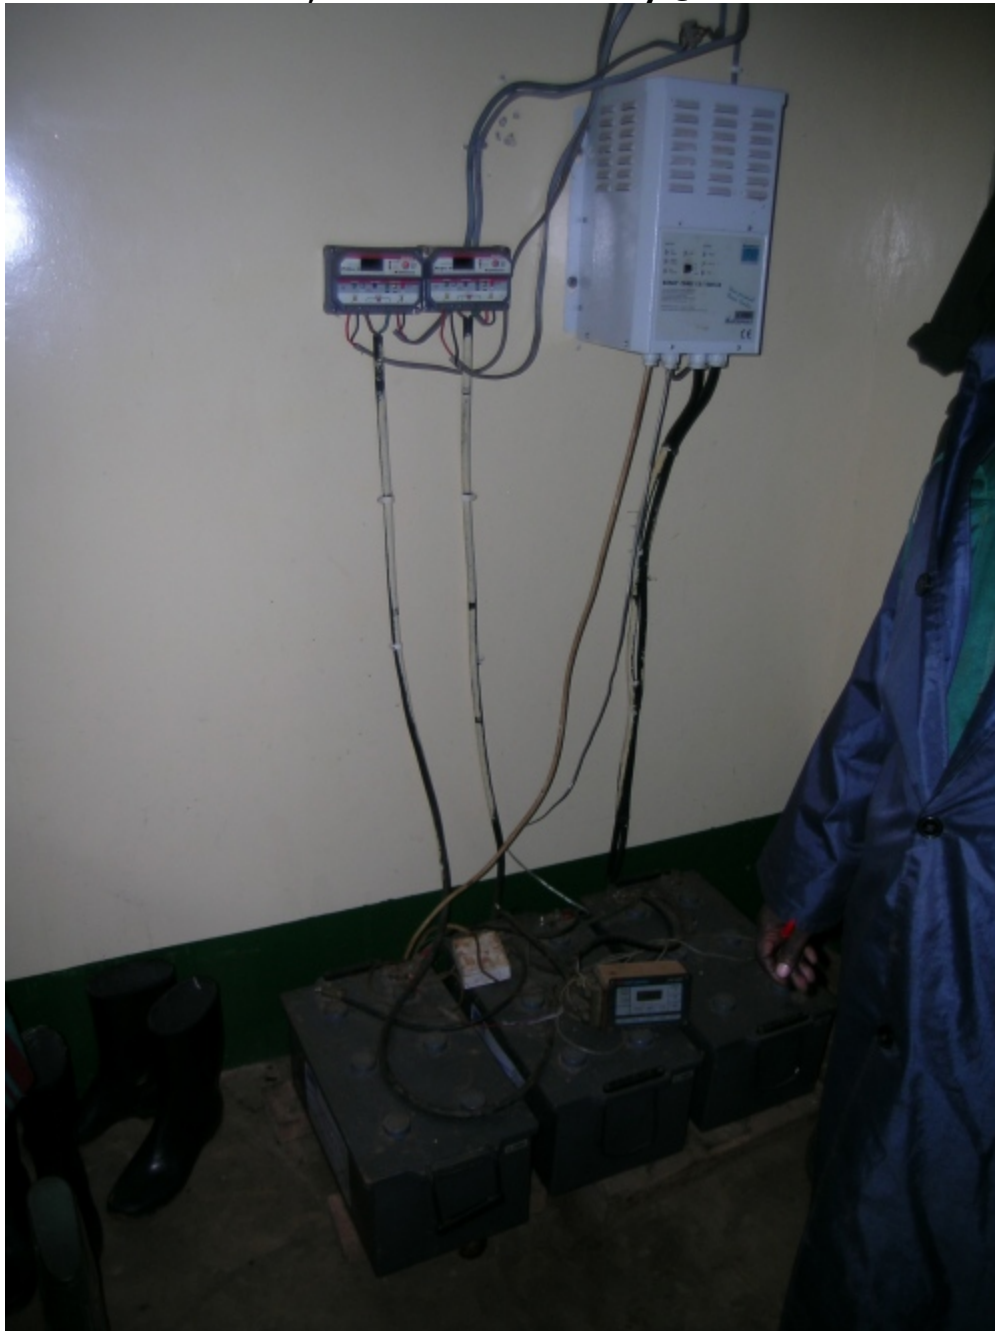
System #4 - ~500 Watts PV, 600 AH sealed battery @ 12 Volts

Another 'professionally installed' system in a national park, this one in Uganda. This system seems adequately sized for the application and the main components are good, they have around 500 Watts of PV on the roof, 600 Amp-Hours of sealed '8D' style deep-cycle batteries and good quality PV charge controllers and inverter/charger. But once again the problem is with the 'balance of systems', how the components are connected together: no circuit protection (fuses or circuit breakers), undersized PV array wires, wiring on the wall was reasonably well secured but not tidy and the wires at the batteries are a mess. These 12V batteries were at 10.5V at 9:00 am. The rangers told me that the lights would work in the afternoon and then go off after a few hours in the evening. The lighting is 12 VDC running off the ProStar 30M charge/load controllers. The system was in a state of

'low voltage disconnect' (LVD) when I saw it. What probably happens is that during the day the PVs charge the batteries up to a high enough voltage to turn on the load controller, but not fully recharge them. Then the lights are used until the LVD turns them off. The inverter has a lower LVD setting and remains on 24/7, running a power strip with several cellphone chargers always plugged in. This has resulted in a chronic undercharging situation where the batteries are never fully recharged and regularly hover around the LVD setting. This is a recipe for disaster and explains why these 2 year old batteries are already wasted.

The rangers had very little understanding of what they should be looking for nor how to best use the system. I suggested they leave the lights off and connect a generator to the inverter/charger to try to rehabilitate the batteries as much as possible. There was no generator input wiring connected to the inverter/charger so they had no easy way to connect a portable generator to top off the batteries. All they need is some extension cord wire and a male plug to hook up a generator once a week to give those batteries a good full topping charge, that would really help those poor batteries.

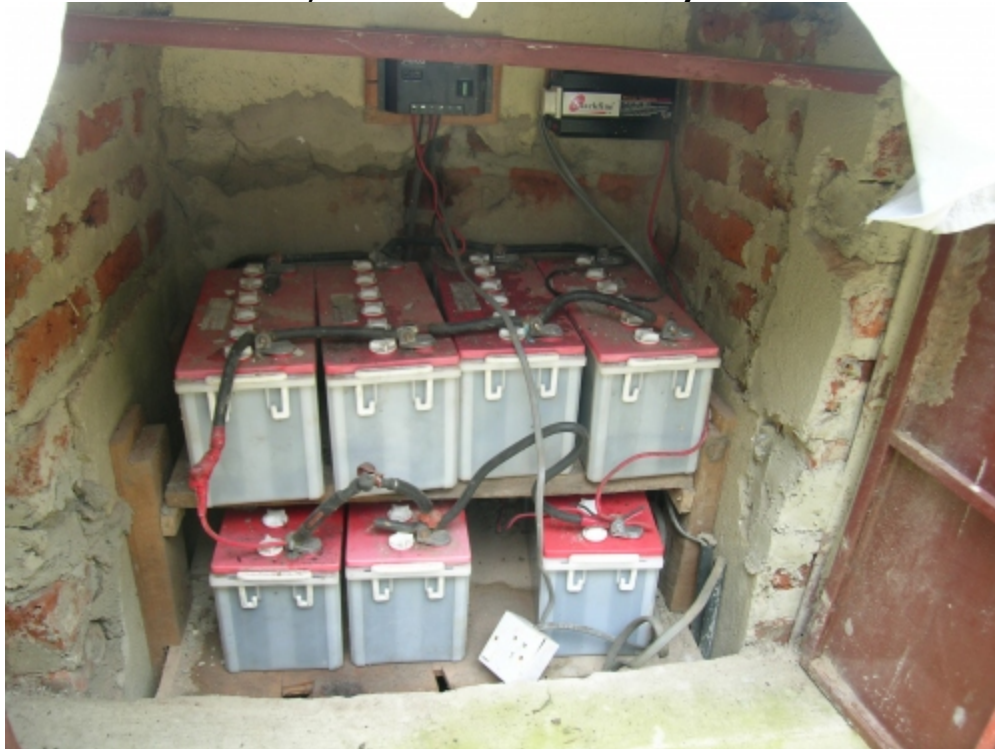
System #5 - ~300 Watts PV, ~900 AH flooded battery @ 12 Volts

Tourist lodge lighting system

This system is running a tourist lodge inside Kibale National Park in Uganda, primarily lighting loads, but all the cabins and tents have AC receptacles so tourists are probably also using battery chargers and small electronics. The biggest problem I see here is that these flooded batteries are not accessible for maintenance, there is no way to check the water level nor add water to the bottom row of batteries. Additionally, the battery cables don't have proper lugs or terminals, the inverter is not fused, the wiring is a mess and the whole package is cramped in the too-small space.

This system is also drawn down to its LVD settings almost daily. There is no external metering or battery health indicators for the lodge employees to monitor and they have little understanding of how to operate or maintain the system.

Additionally, the guests at the lodge are given complete access to 240VAC power without any special instructions about the limited nature of their electricity supply. Many people (Westerners especially) are so clueless about energy conservation that I could see people leaving their bathroom or outside lights on all day and night without realizing the consequences.

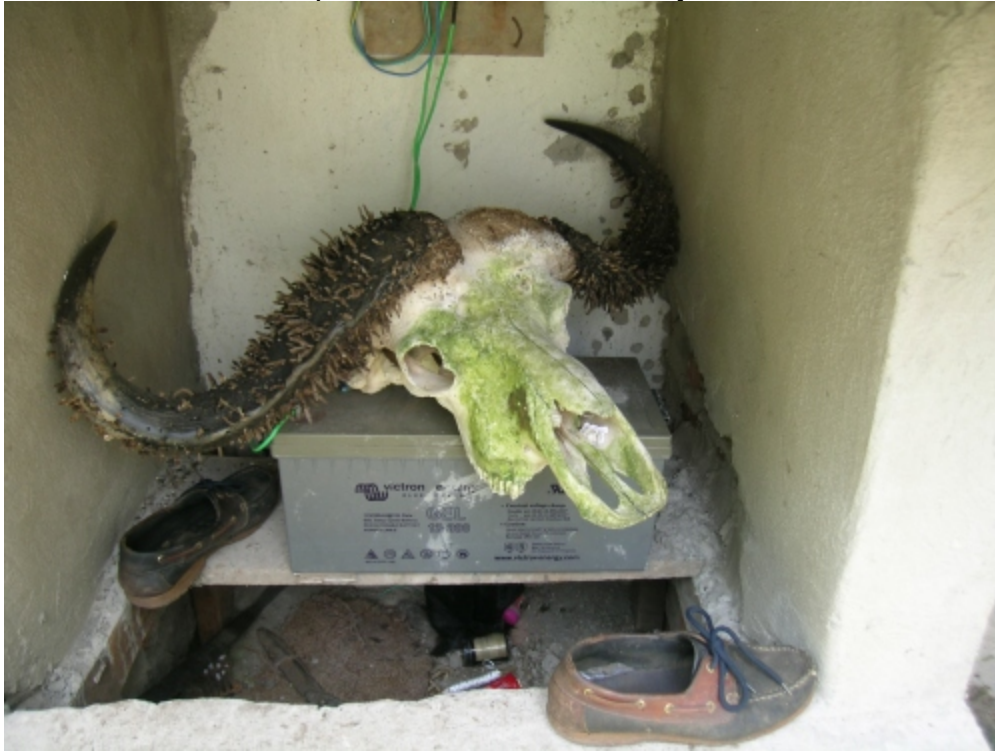
System #6 - ~400 Watts PV, ~200 AH sealed battery @ 12 Volts

This battery helps to run a 12V deep-freezer at the same lodge as above. This is a load that is well matched to its dedicated PV array and I don't see any real performance problems with the system, the battery is being well cared for. As long as no new loads are added it should run the freezer for many years. Personally I think the buffalo skull is a nice touch, and the VRLA sealed battery does not need maintenance so it does no harm sitting there. Still, not exactly 'professional grade' looking installation, some fuses and a meter would be good improvements.

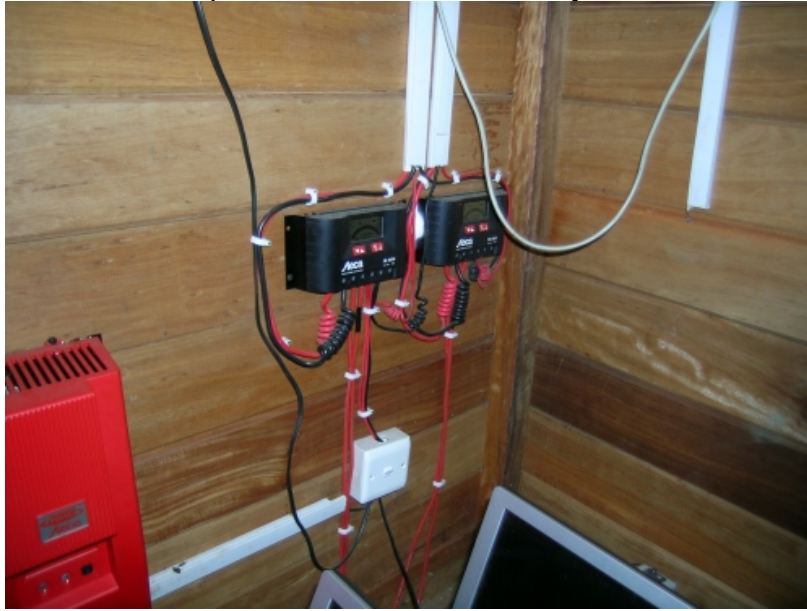
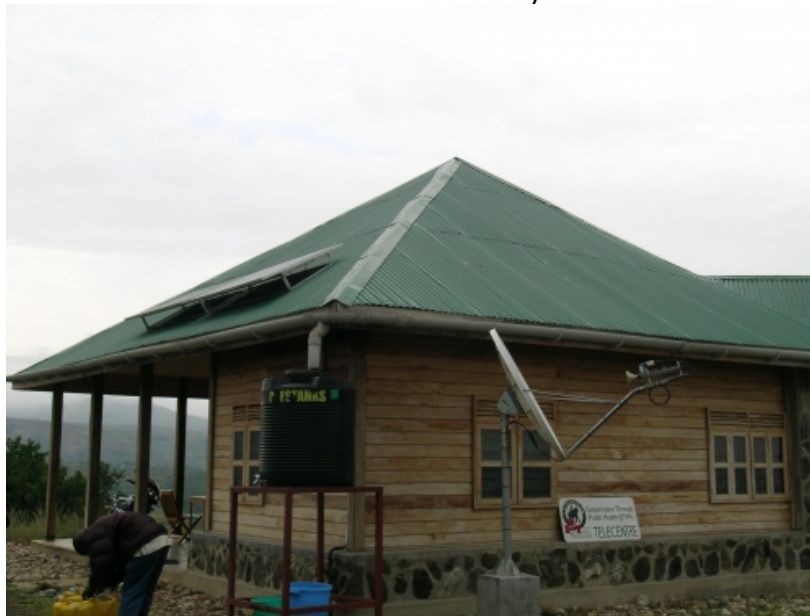
System #7 – ~650 Watts PV, ~400 AH sealed battery @ 12 Volts

Satellite internet cafe system

PV array, rainwater catchment, VSAT dish

Nicest quality system I saw in Africa. But I'm not sure why the controller wires are twisted and dangling like that. It looks like a phone handset cord, or as if the controller was going to bungee jump off the wall. Runs an satellite internet cafe at Queen Elizabeth National Park, Uganda. It was the fastest internet connection I found during the whole trip. We watched some of my [YouTube videos](#).

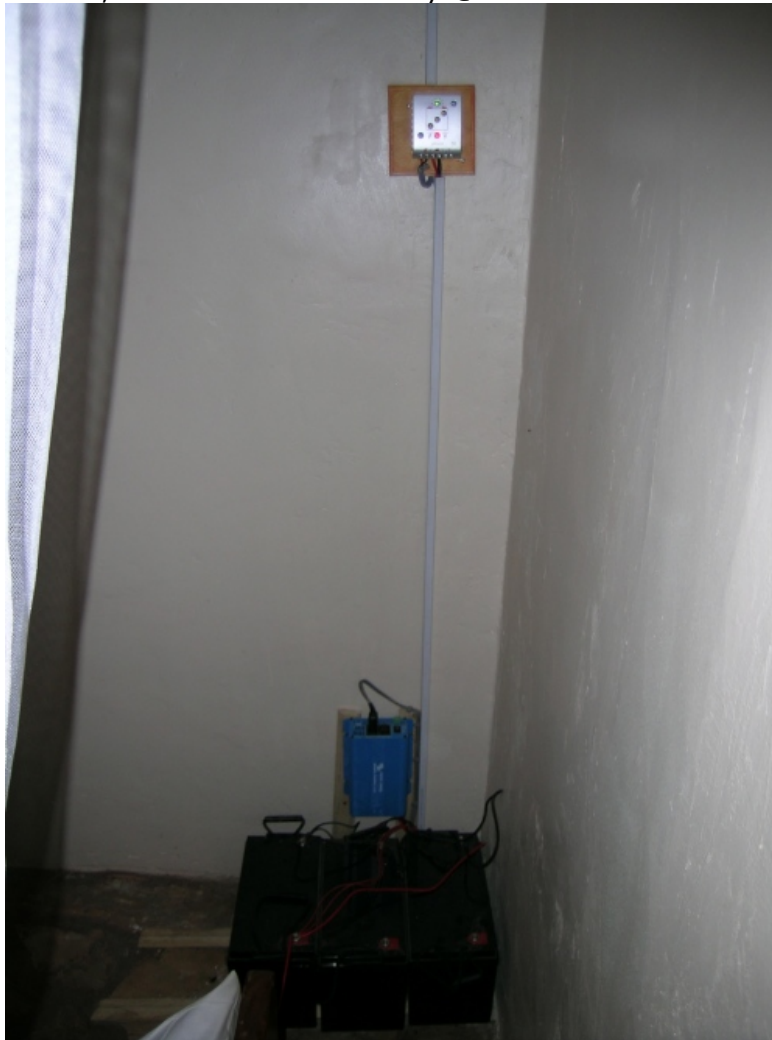
System #8 - ~200W PV, ~600 AH sealed battery @ 12 Volts

Tourist lodge near Queen Elizabeth N.P. Same problems: no fuses, no meters, no battery lugs, undersized PV array wire, regular LVD load control and little O&M understanding by system users. This system is chronically undercharged, they need to reduce their load with better conservation and efficiency measures and also increase the PV array. I suggested a timer or remote switch for all the loads, so they only provide power for a few set hours per day. That could help eliminate the problem of lights being left on all day and night. Another PV module or two would be really good too, especially with the ongoing expansion of the lodge and increasing lighting requirements.

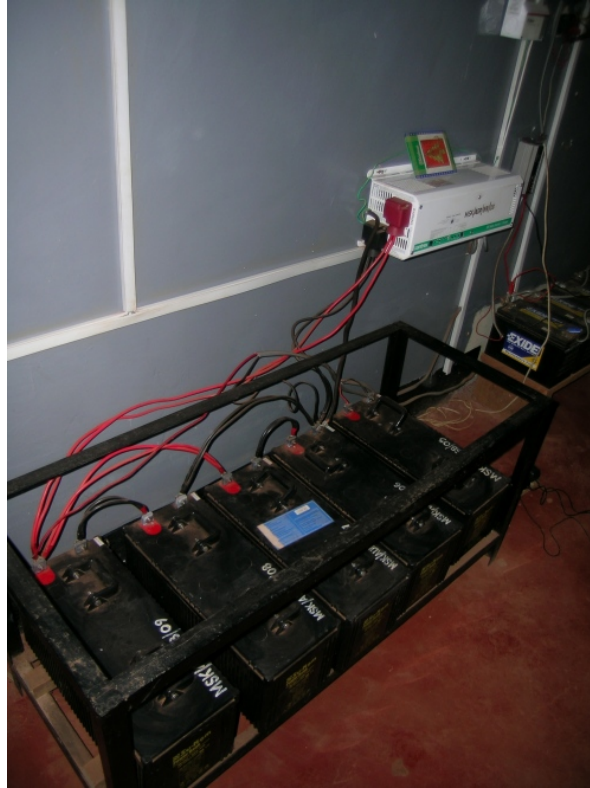
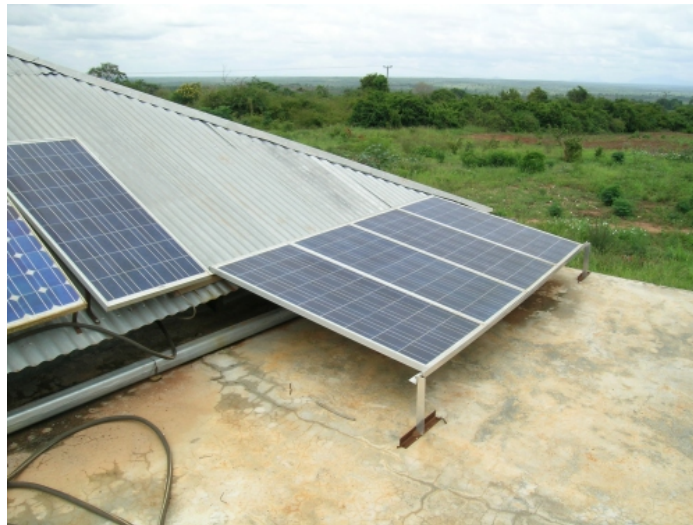
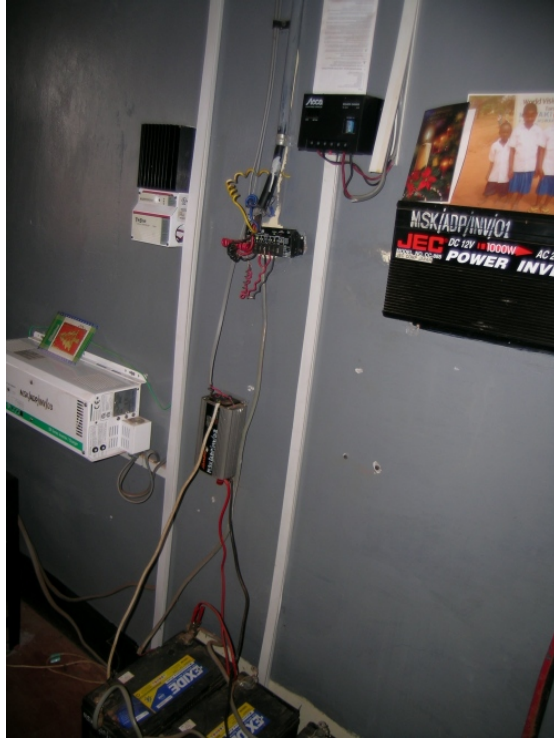
Rural office in Tanzania

These next four pictures are all from a rural office in Tanzania run by a large international development aid organization, they have 3 systems of different ages operating in parallel.

System #9 - ~480 Watts PV, ~400 AH sealed battery @ 24 Volts

System #10 - ~160 Watts PV, ~200 AH sealed battery @ 12 Volts

System #11 - ~100 Watts PV, ~150 AH sealed battery @ 12 Volts

This 'professionally installed' system in a remote Tanzanian village runs a medium sized office including 3 desktop computers with LCD monitors, occasional additional laptops, two printers, a VSAT satellite internet system and 6 to 10 lights for several hours each night. They are running at a regular energy deficit, with the average baseload of the office exceeding the charging capacity of the PV array. There are actually 3 different systems running here in parallel. They have the same problems as the others: no fuses, no meters, undersized wires, inappropriate terminals and generally sloppy looking wiring. Most of the loads were on the biggest system, with about 500 Watts of PV on a 400 AH battery @ 24 Volts. The 24V system was at 23 Volts in the middle of a bright sunny African afternoon. The PV array was producing about 18 amps and the loads were consuming around 26 amps. While the office is occupied this load is fairly constant. It was a little cloudy when I was there so they might see a bit over 20 amps with better sun, but that is just not enough to keep up with the load. The office is

closed on the weekend, and it seems that is the only time the batteries get close to a full charge. They need more PVs and some metering so they can take better care of the batteries. There was no way for them to read the battery voltage at all. That is bare minimum essential equipment in my opinion.

Also, the 24V system has a good DR inverter/charger that could really help those batteries with an occasional recharge from a portable generator but there was no AC input wiring connected to it. Just like in Uganda, all they need is an extension cord and a plug and they would be able fully recharge the batteries occasionally until they can get more PVs installed. As it currently is running I don't think the batteries will last more than a year.

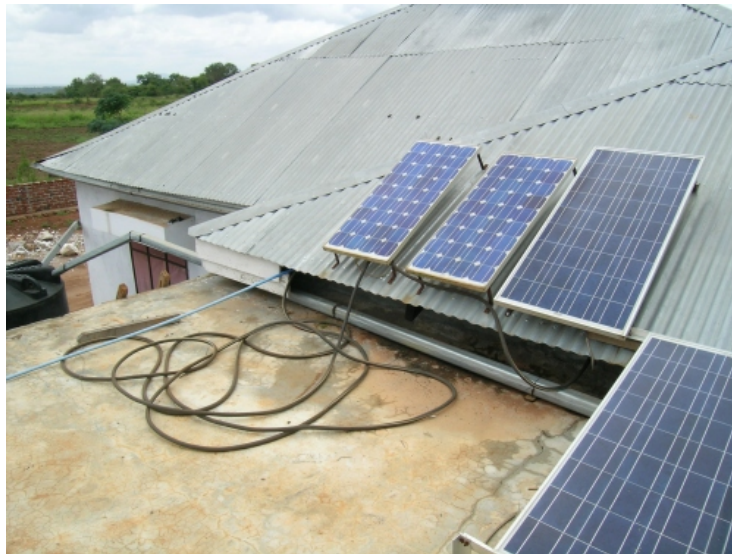
The last picture showing the modules on the roof is a really extreme example of something I saw pretty often. The installers are reluctant to cut wires and cables to the proper length! They often leave huge loops or coils of excess wire. In a 12V PV charging circuit, this practice, along with undersized wires, results in unfortunate and avoidable power loss through voltage drop. Wire is cheap compared to PV modules and batteries. Don't choke out your array with wires too small and too long!

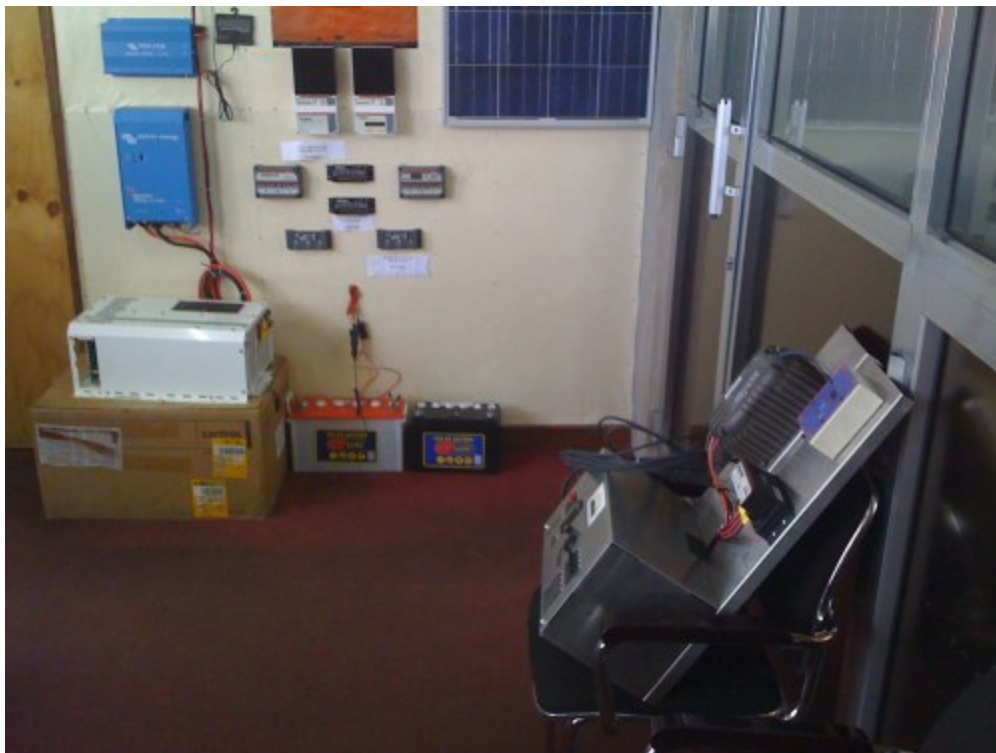
SolarNexus v1.0 prototype at Ensol Ltd office in Dar Es Salaam, Tanzania

Okay, have I convinced you that the solar electric industry in Africa could use improvement? How do I propose we do it, you ask? Well, one solution will hopefully be the [SolarNexus](#), the new off-grid electric system product from [Solar Nexus International](#). I took a prototype version of the Nexus over to Tanzania and showed it around to solar dealers and prospective end-users. People liked it. They see the obvious value of an integrated package that includes pre-wired circuit protection, high quality electronics and metering. On the plane ride home I came up with the next design iteration:
